TECHNICAL ASSISTANCE TEAM FOR EMERGENCY RESPONSE REMOVAL AND PREVENTION  
EPA CONTRACT 68-01-7367

Re: Selmer (AKA Superior Street)  
Elkhart, Indiana  
TDD# 5-8903-21

On April 21, 1989, the U.S. Environmental Protection Agency (U.S. EPA) tasked the Technical Assistance Team to monitor Potentially Responsible Party (PRP) activities at the Selmer (AKA Superior Street) site in Elkhart, Indiana (Figure 1). This letter report provides a site description, a brief site history, and a discussion of PRP activities completed to date.

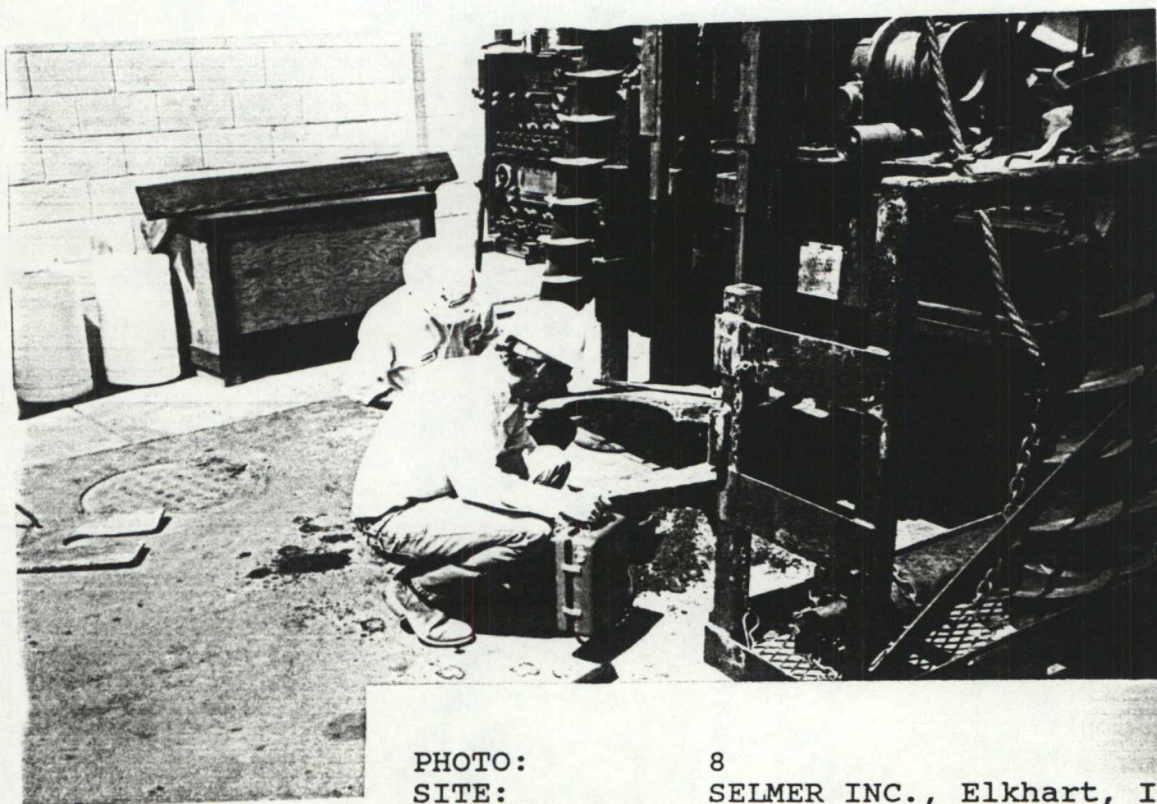
PHOTO: 8  
 SITE: SELMER INC., Elkhart, Indiana  
 DESCRIPTION: EIS geologist screening  
 cuttings with organic vapor  
 analyzer at Borehole 2  
 location.  
 DATE/TIME: 4/26/89 (1000 - 1730 hours)  
 PHOTOGRAPHER: Binkley<sup>J-78</sup>

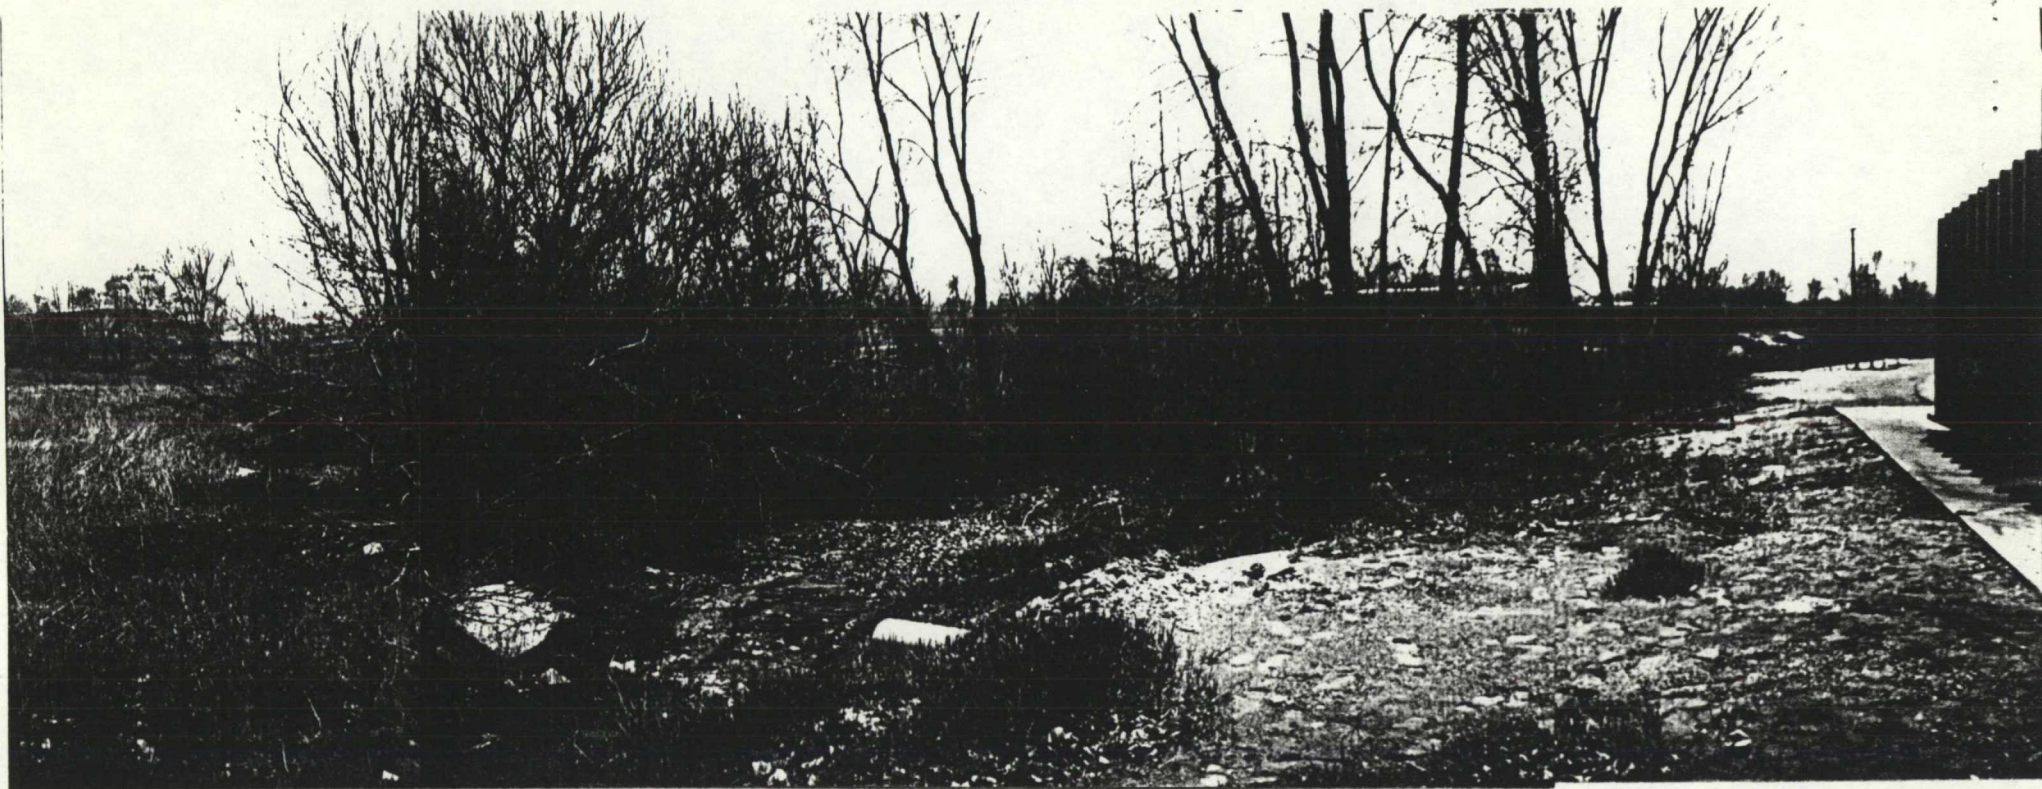
PHOTO: 9  
SITE: SELMER INC., Elkhart, Indiana  
DESCRIPTION: View looking south/southeast  
from near alleged dumping area.  
DATE/TIME: 4/26/89 (1000 - 1730 hours)  
PHOTOGRAPHER: Binkley *JB*
